HABITAT CONDITIONS

Channel Alterations

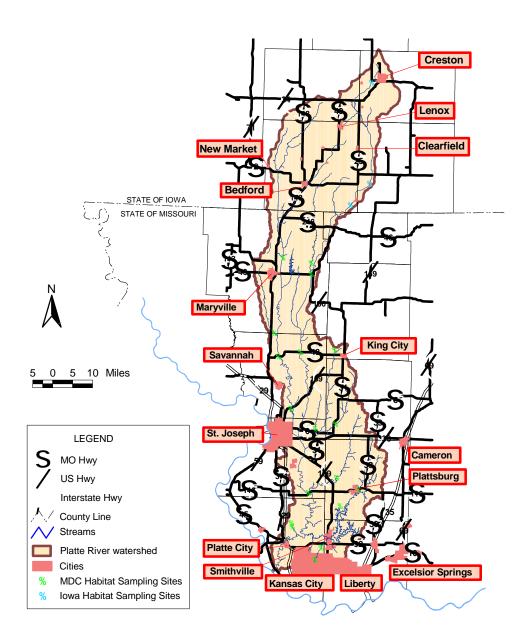
Figure hs. Habitat sampling sites within the Platte River basin in Missouri and Iowa.

Stream habitat was described qualitatively within the Missouri portion of the Platte River basin at the 18 sites (Figure hs) sampled for fish community composition in 1995 and 1996. The homogenous habitat conditions throughout the basin allowed generalizations to be made with regard to stream habitat conditions within the basin. Streambanks along channelized reaches were highly susceptible to erosion (bank stability ranked as fair to poor) resulting in poorly vegetated (generally herbaceous vines with shallow root systems), high vertical stream banks. In areas that were not channelized, streambanks generally were more stable (usually had stability ranking of good), and over 50% of the streambank vegetation consisted of trees and shrubs.
